GDC Project No. GF 2078

ENGINEERING INVESTIGATION REPORT

Site Location: 497 S. Lake Avenue
Pasadena, CA 91101

Purpose of this Report: To evaluate existing damages to the structure and the extent of damages resulting from three overgrown ficus trees adjacent to the property.

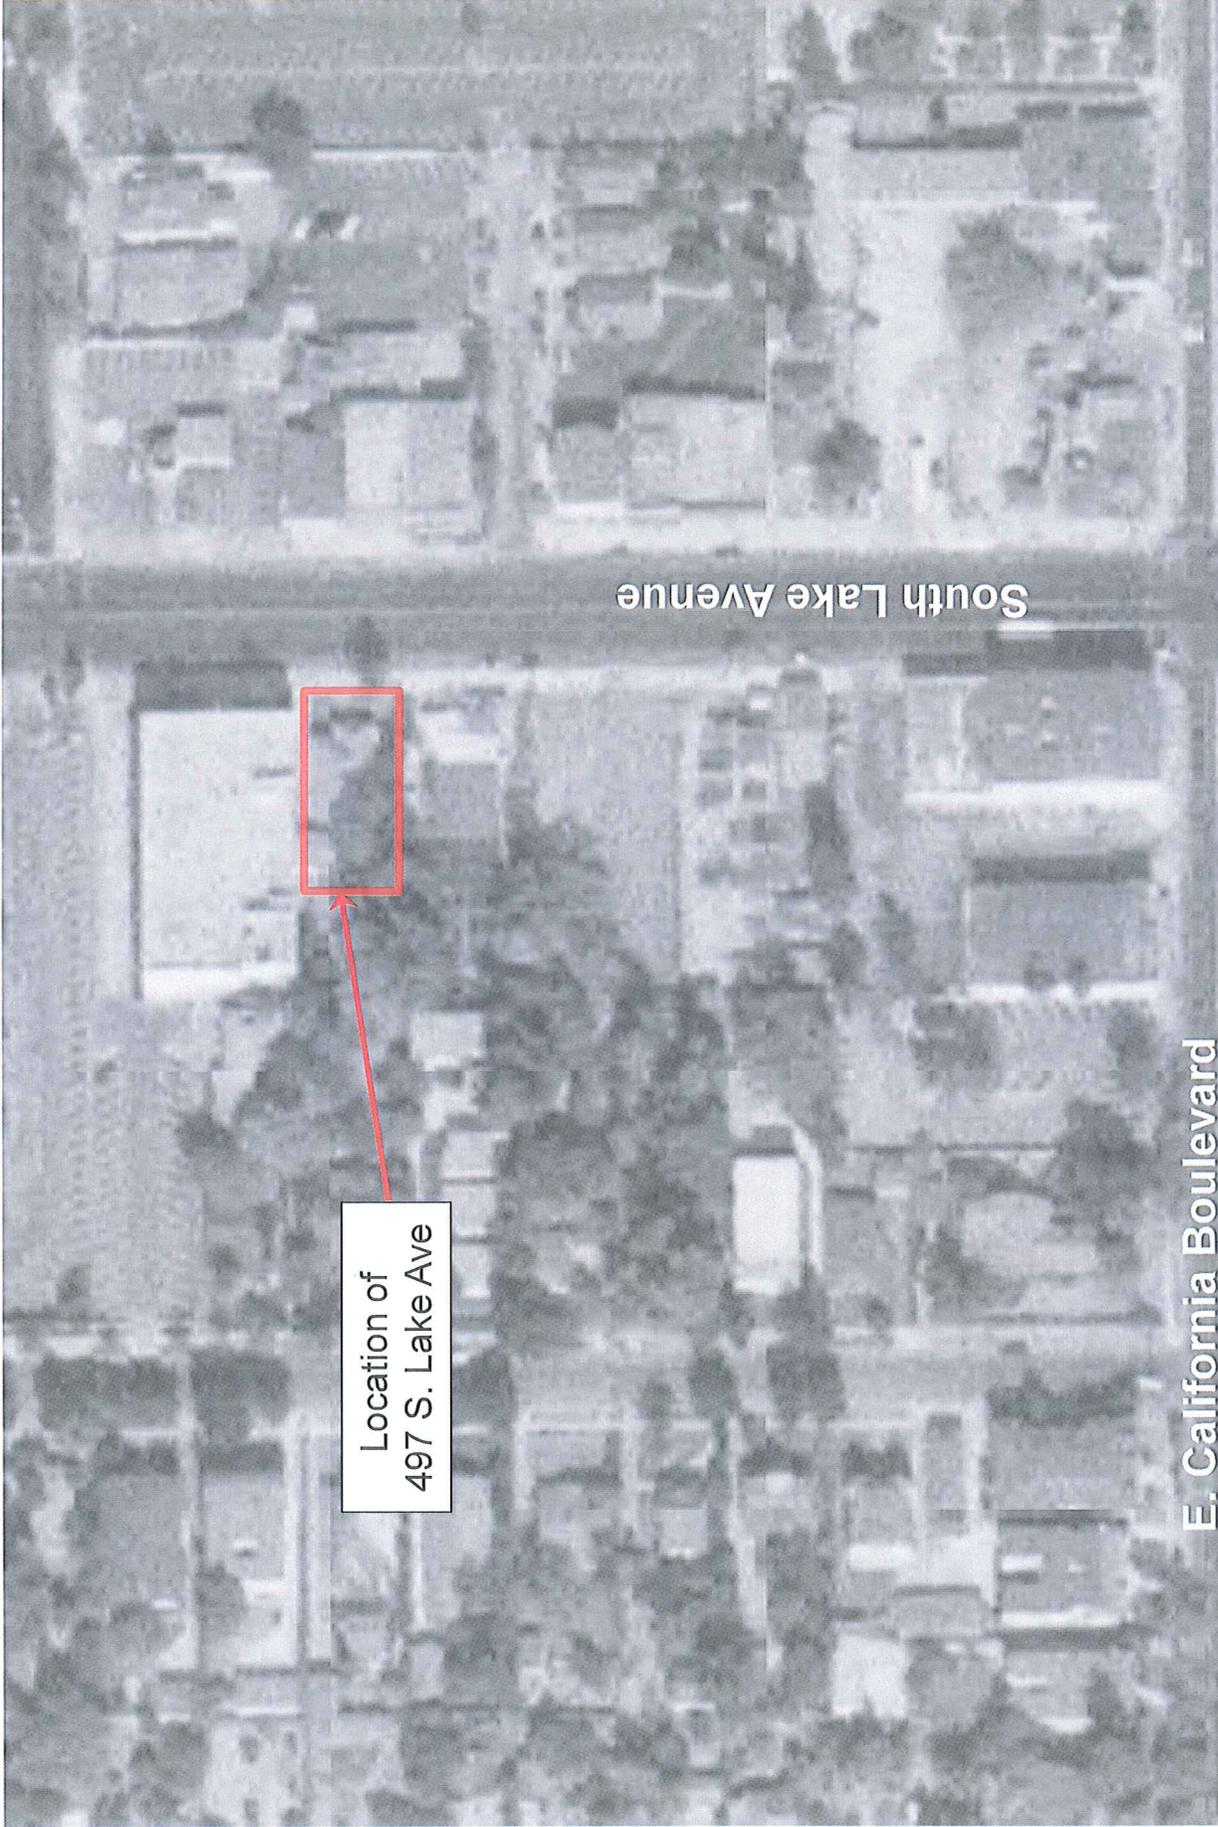
GROUP DELTA CONSULTANTS, INC. ENGINEERS AND GEOLOGISTS	FIGURE NUMBER 6
	PROJECT NAME: 497 S. Lake Ave., Pasadena, CA	PROJECT NUMBER GF-2078
CASE NUMBER: BC542643		Date: October, 2015

- Aerial photographs dated 1953 (Figure 6), show that the site (497 S. Lake) was not yet developed and was occupied with vegetation.
- Aerial photographs dated 1954 (Figure 7), show that the site has been cleared of the vegetation.

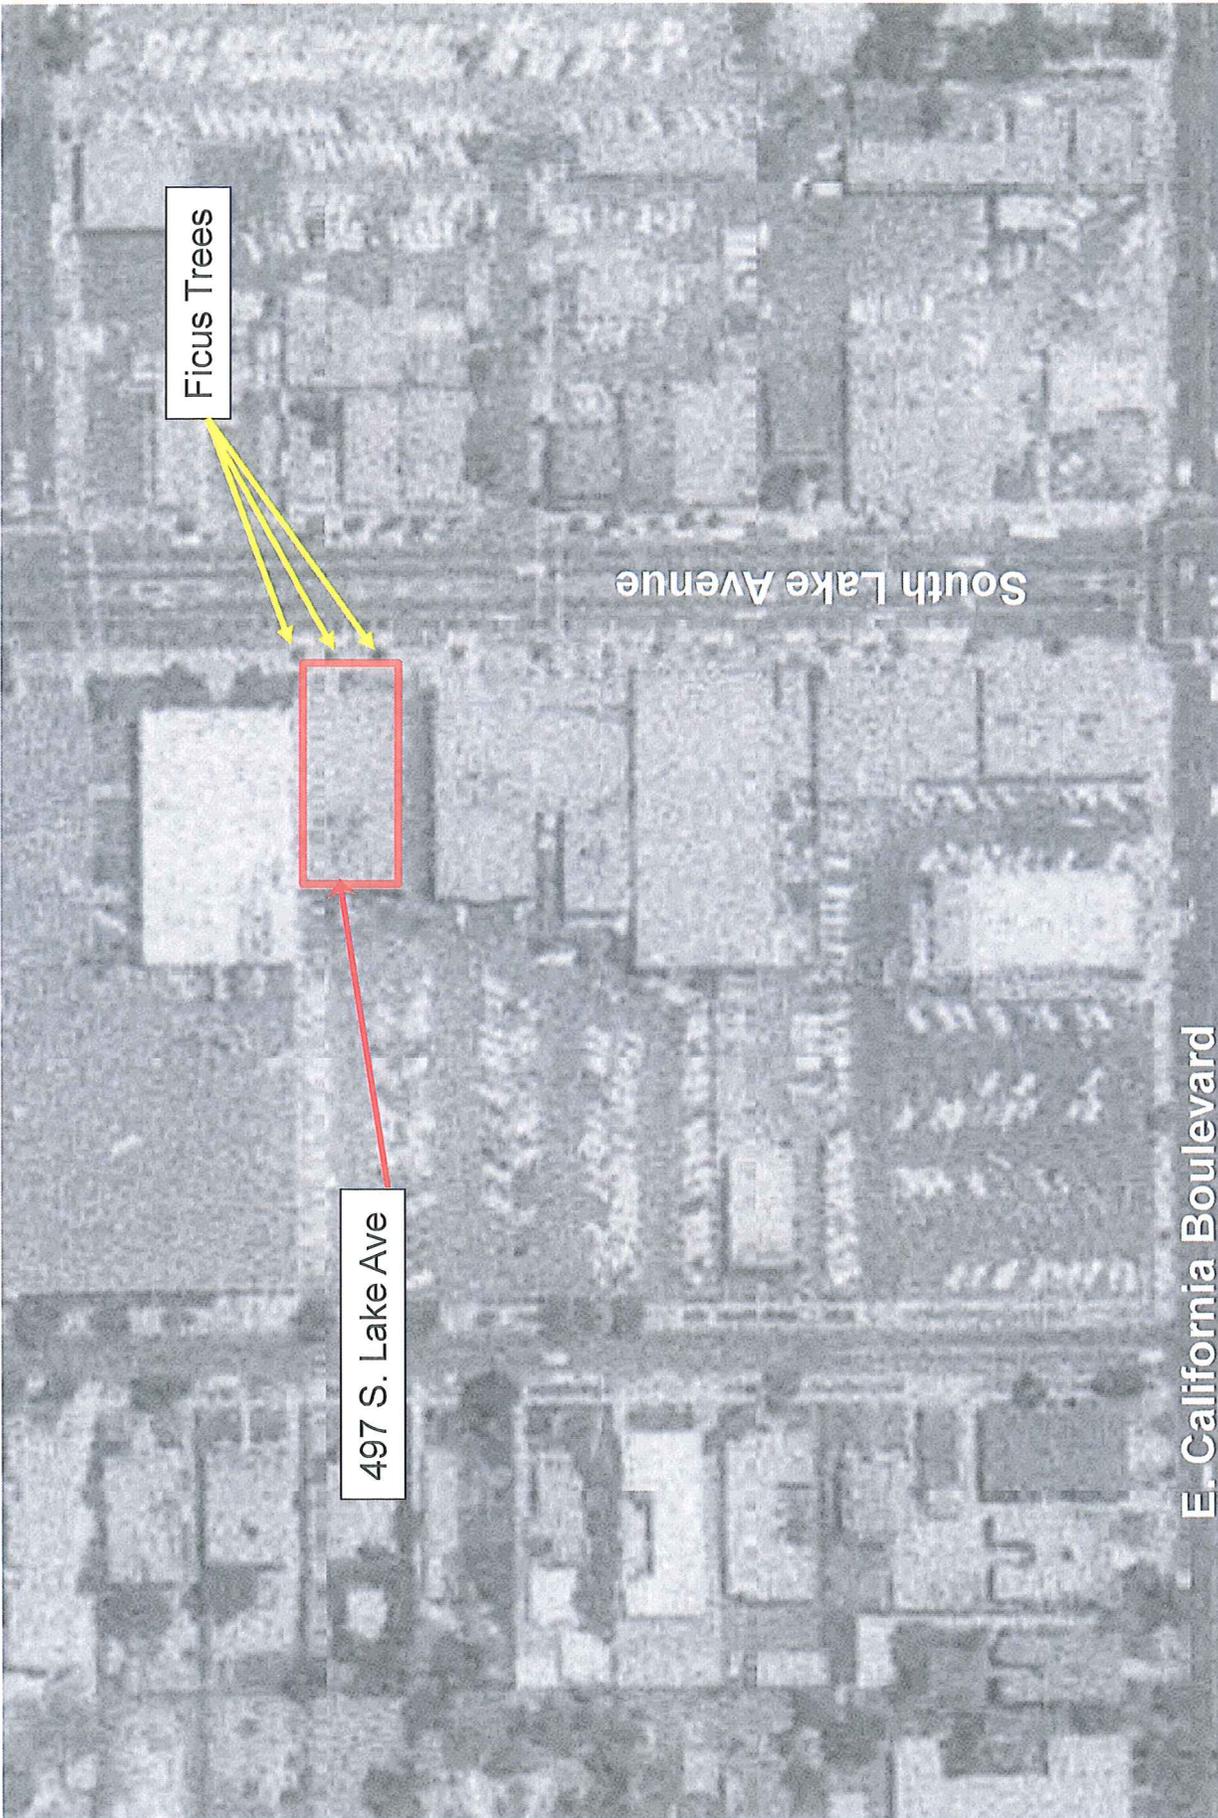
FIGURE NUMBER
8

- Aerial photographs dated 1964 (Figure 8), show that the structure had been built and a row of small trees along the sidewalk on S. Lake Avenue, east of the subject site. These trees appear to be relatively small, and separated from each other, suggesting that they had been recently planted when the aerial photograph was taken.
- Aerial photographs dated November 2003 (Figure 9) show mature ficus trees along the property line compared to the 1964 aerial photograph (Figure 8). The ficus trees appeared to have been overhanging the front portion of the building.
- Aerial photographs dated 2007 and 2015 (Figures 10 and 11) show the ficus trees have grown larger and overhang a larger area of the front (east) portion of the building.

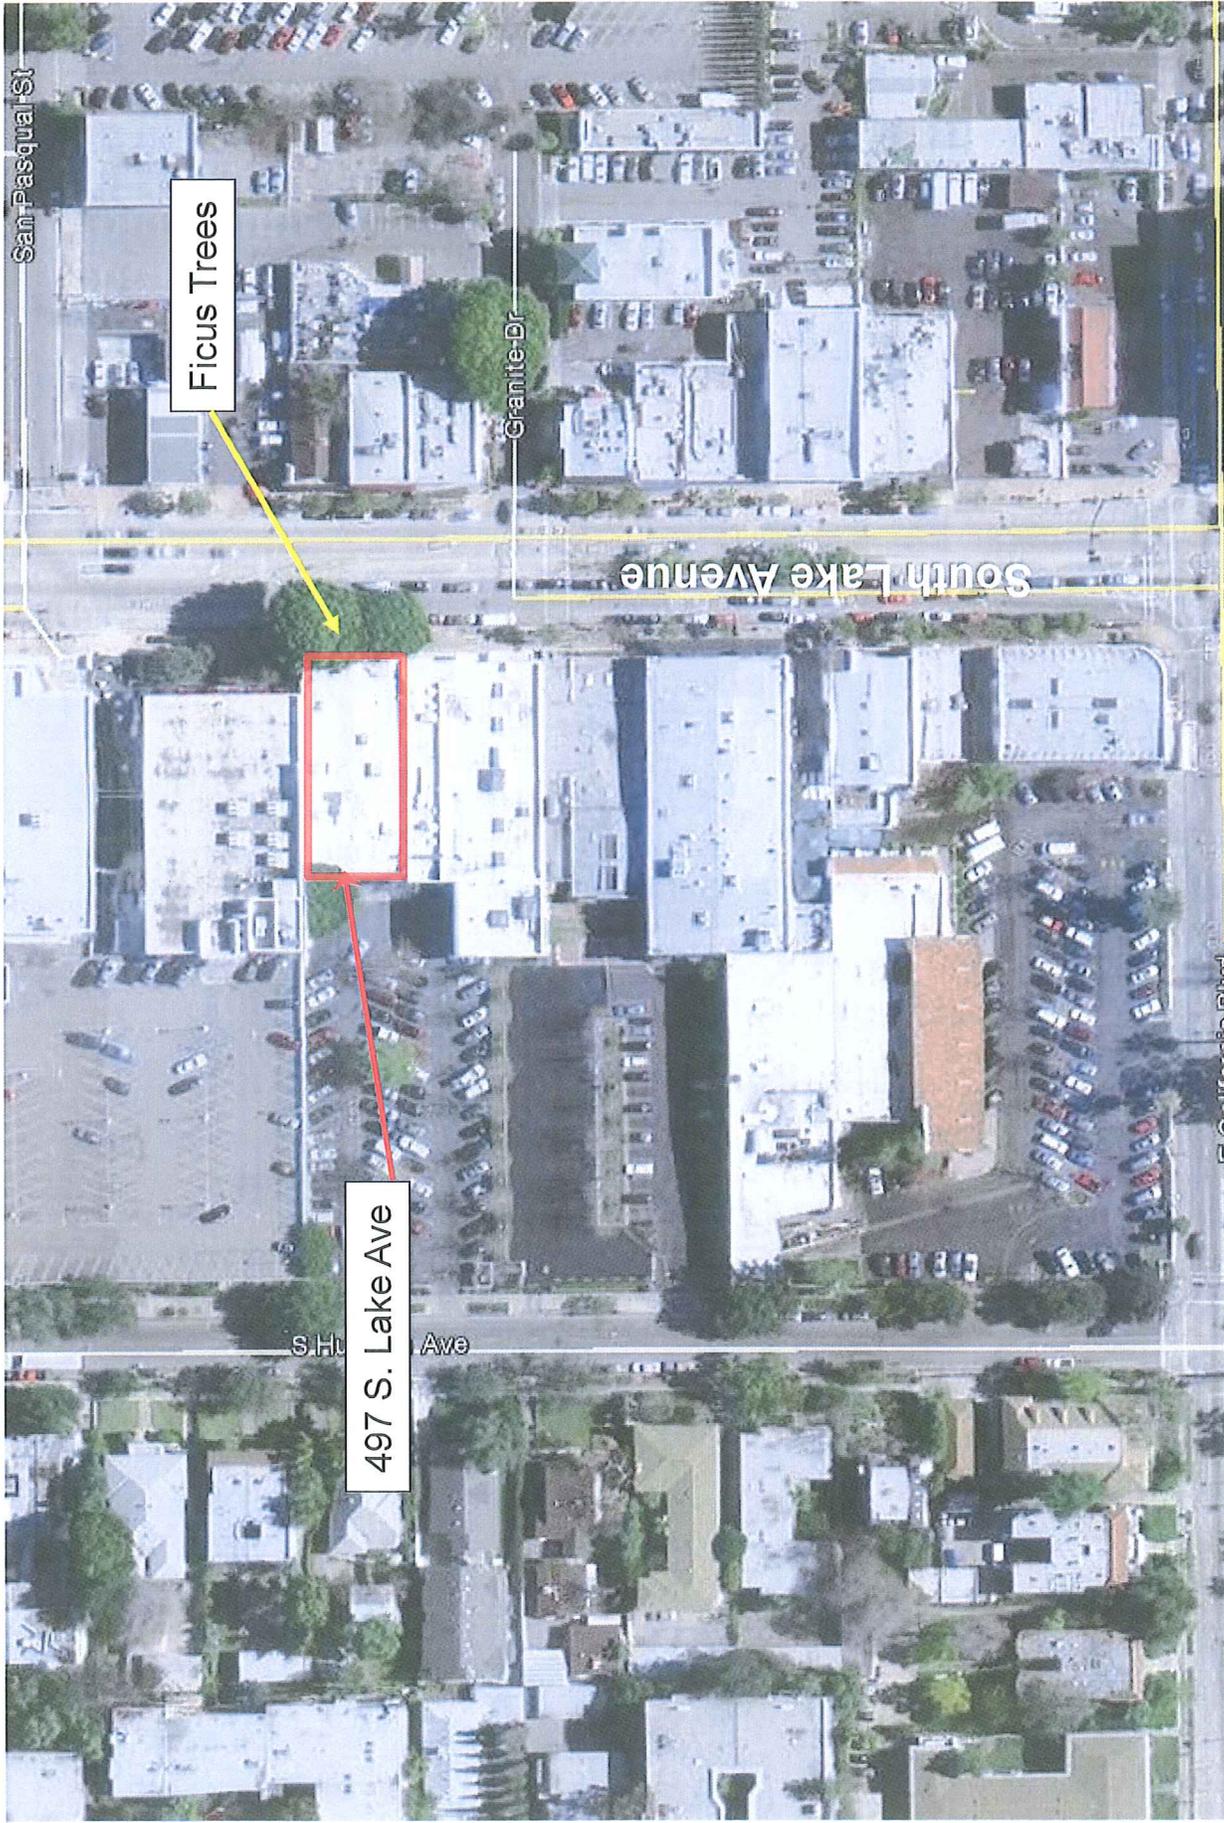
FIGURE NUMBER
9

For more than several years, three very large ficus trees have been overhanging the front portions of the subject building roof (Figures 2 to 5 and 9 to 11). Leaves and other tree debris continuously fall upon the roof causing roof drain blockages. During rains this can result in water ponding upon the roof front two corners to a depth of at least 1'-6". At the surface level, large tree roots are heaving up and fracturing the front public sidewalk, causing damages to the concrete sidewalk as well as raised edges and out of level concrete surfaces, resulting in a pedestrian trip hazard. Leaves, berries and other debris from the trees cover portions of the subject roof and the front sidewalk access to the building.

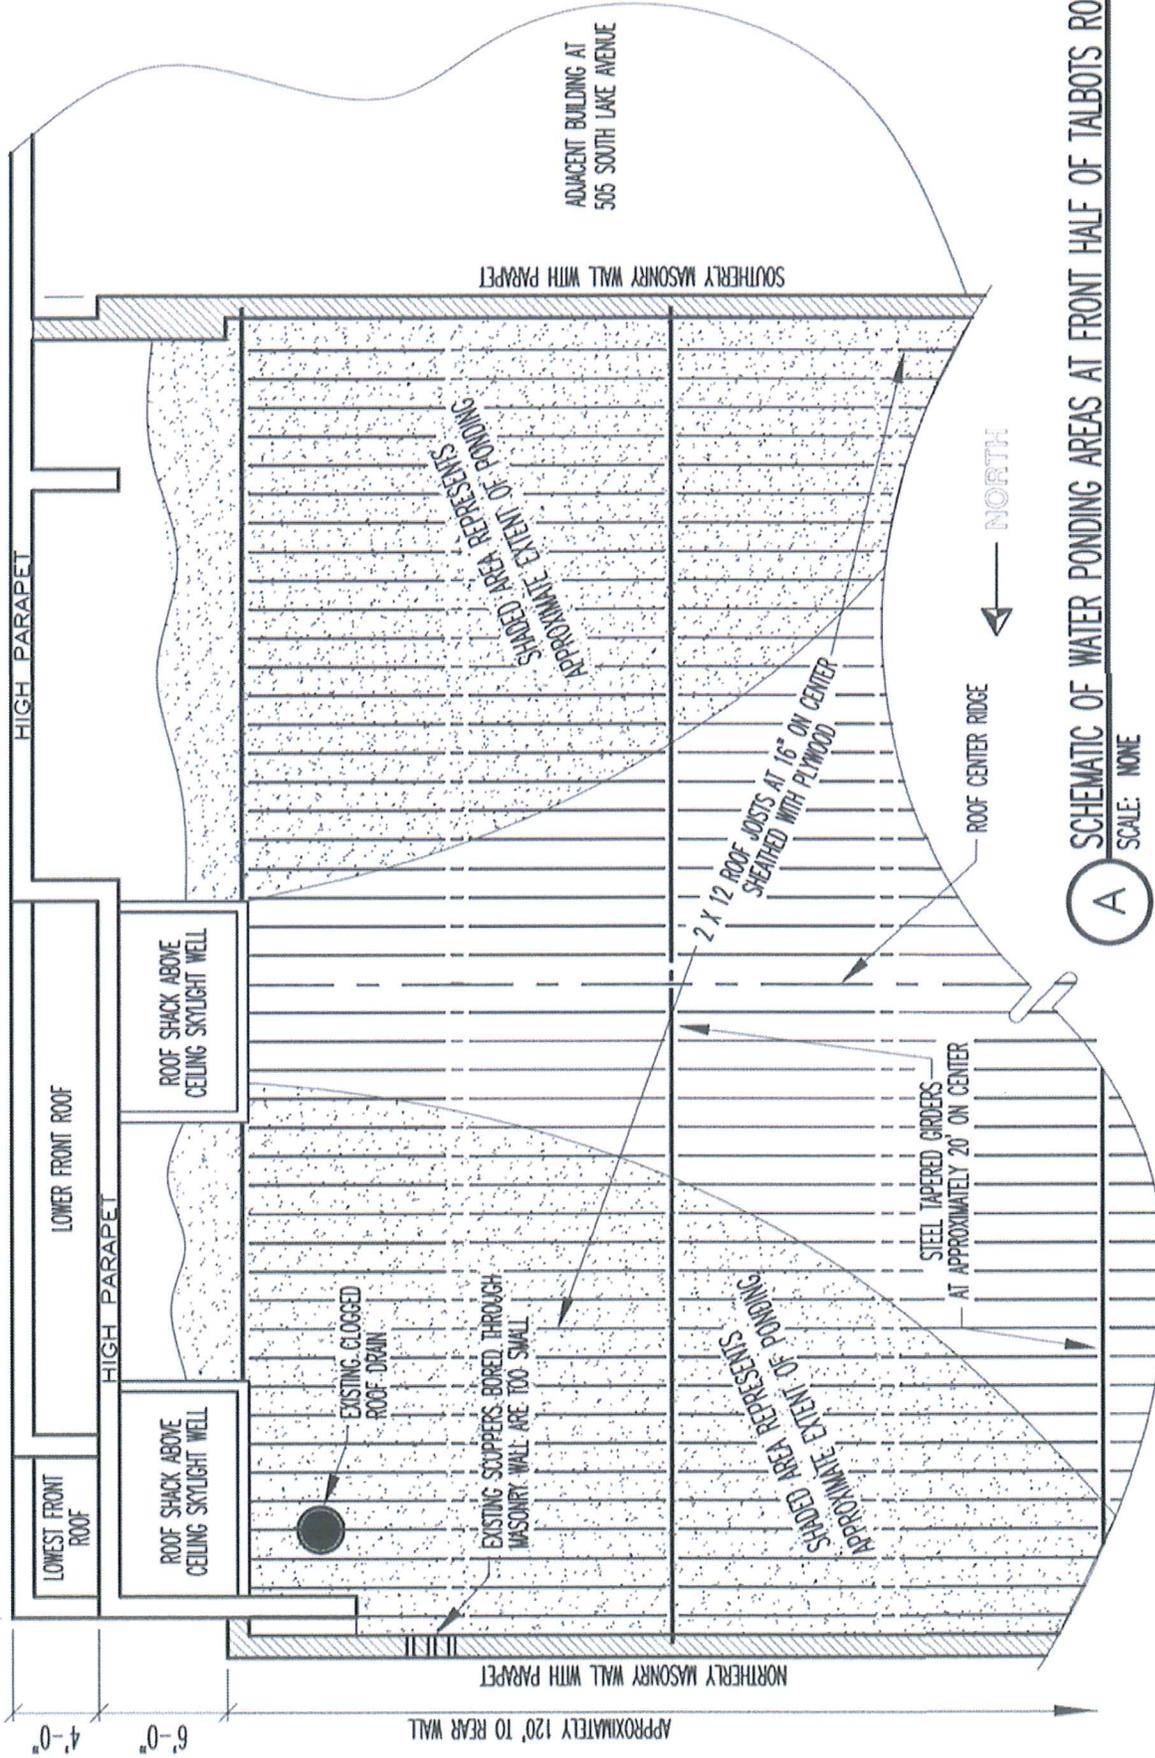
A SCHEMATIC OF WATER PONDING AREAS AT FRONT HALF OF TALBOTS ROOF
SCALE: NONE

Based upon observed parapet heights, we estimate that, at the very least, 1'-6" of water will pond at the buildings two front corners before it begins to run over the central high point of the roof (Figure 12).

A 1'-6" depth of water weighs approximately 94 psf. Low slope roofs, as at this building, are designed to support an additional service live load of 20 psf above their actual weight. Allowable bending stress values for #2 Douglas fir joists with a duration of load increase for roofs is approximately 1562 psi. Our preliminary structural calculations indicate that the 2x12 roof joists below the area of ponding would be stressed to approximately 2673 psi, at least 70% overstressed above the building code allowable design values, and that at those areas local roof collapse is a serious risk.

The depth of water ponding that has repeatedly occurred is truly dangerous. In the event that future roof drain blockages may continue, emergency overflow scuppers should be constructed at all four

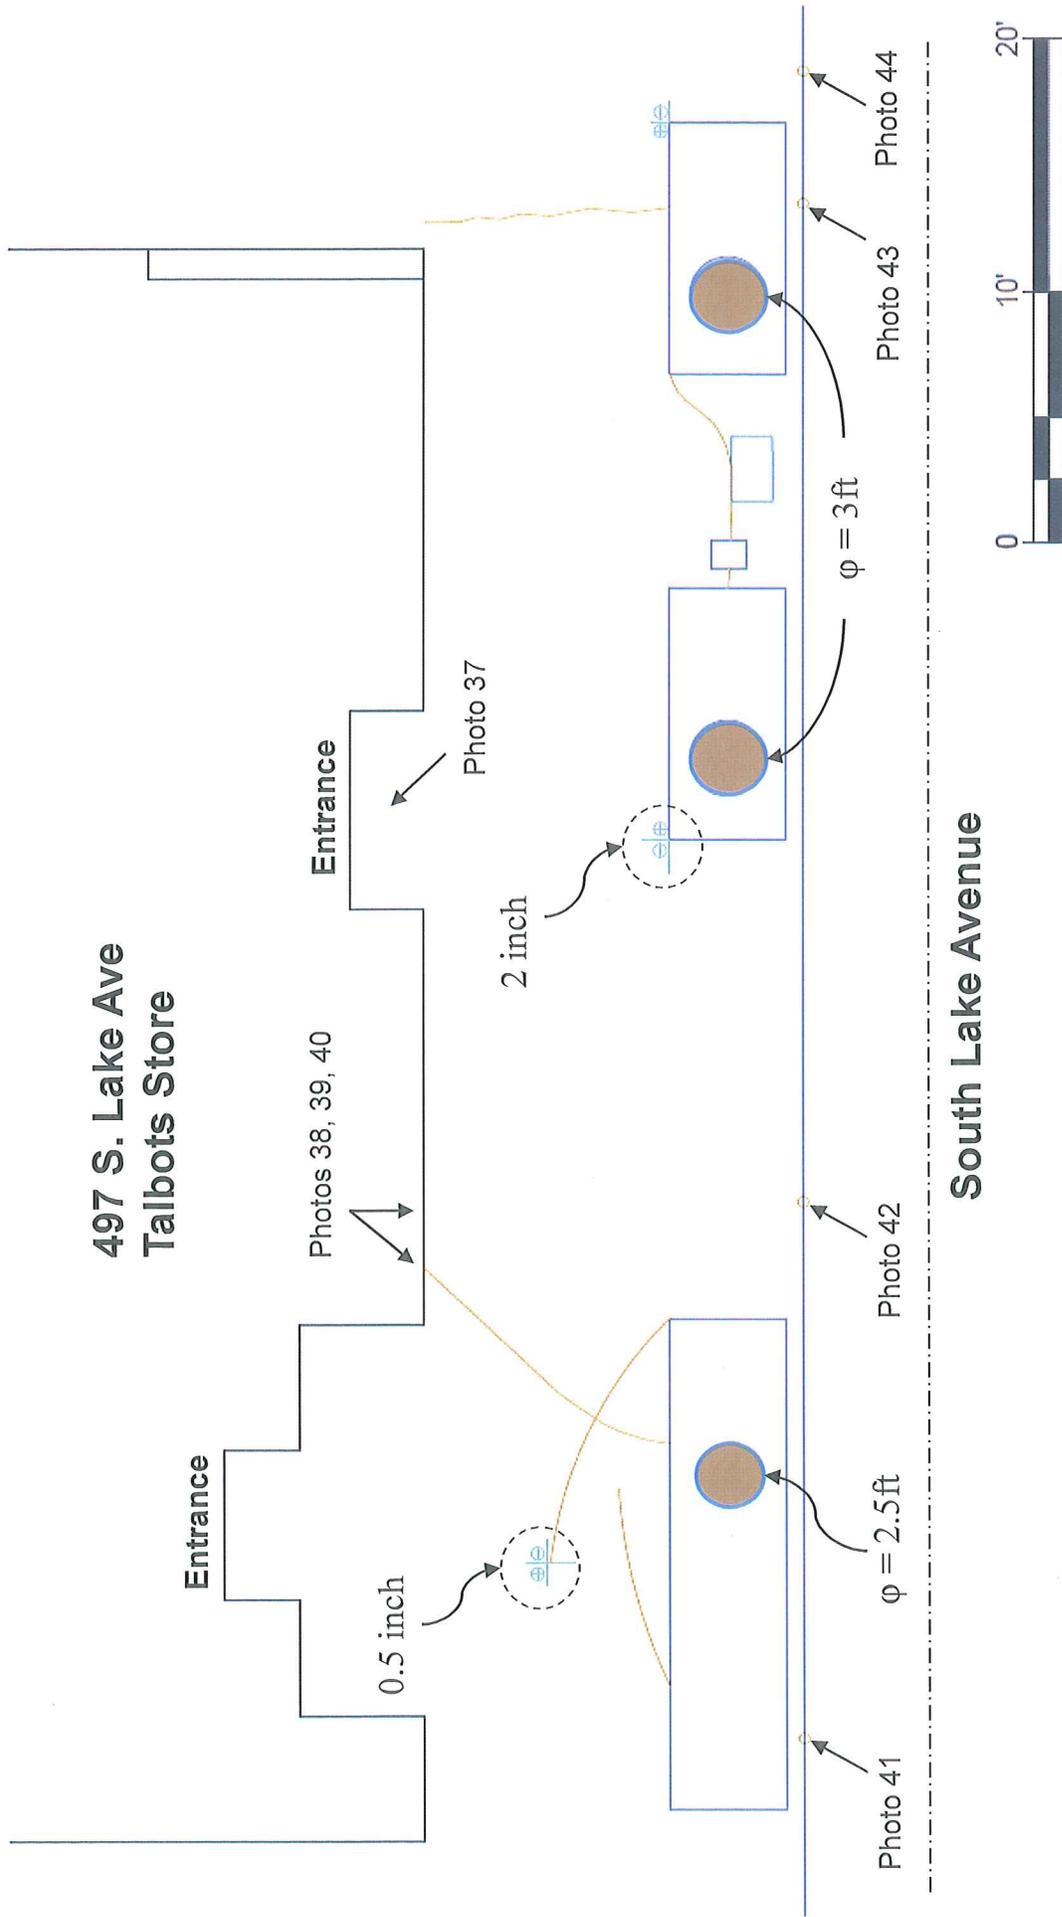
GROUP DELTA CONSULTANTS, INC. ENGINEERS AND GEOLOGISTS	FIGURE NUMBER 13
PROJECT NAME: 497 S. Lake Ave., Pasadena, CA	PROJECT NUMBER GF-2078
CASE NUMBER: BC542643	Date: October, 2015

The front sidewalk concrete is heaved up and fractured by large tree roots (Photos 30 through 33). The crack locations and damage pattern are associated with growth of the subject tree roots. This action is destroying the sidewalk and causing raised edges and out of level surfaces resulting in a pedestrian trip hazard. The vertical offsets in the sidewalk have been patched at several locations, in an apparent attempt to reduce the trip hazard associated with the offsets (Photos 34, 35 & 36). Some of the vertical offsets are up to 2 inches.

We observed four curb drain outlets in front of the subject building that are between 3.75 to 4.25 inches in diameter (Photos 41, 42, 43, 44). We observed that all of these drains have some degree of infilling with dirt and debris. Another curb drain, just north of the ones discussed above, is the furthest from the ficus trees and has roots that appear to be growing out of the drain (Photo 45).

At the very least tree limbs should be cut back, clear and away, from the front of the building so that no branches overhang the roof. To prevent further sidewalk and building damages, tree removal will be required.

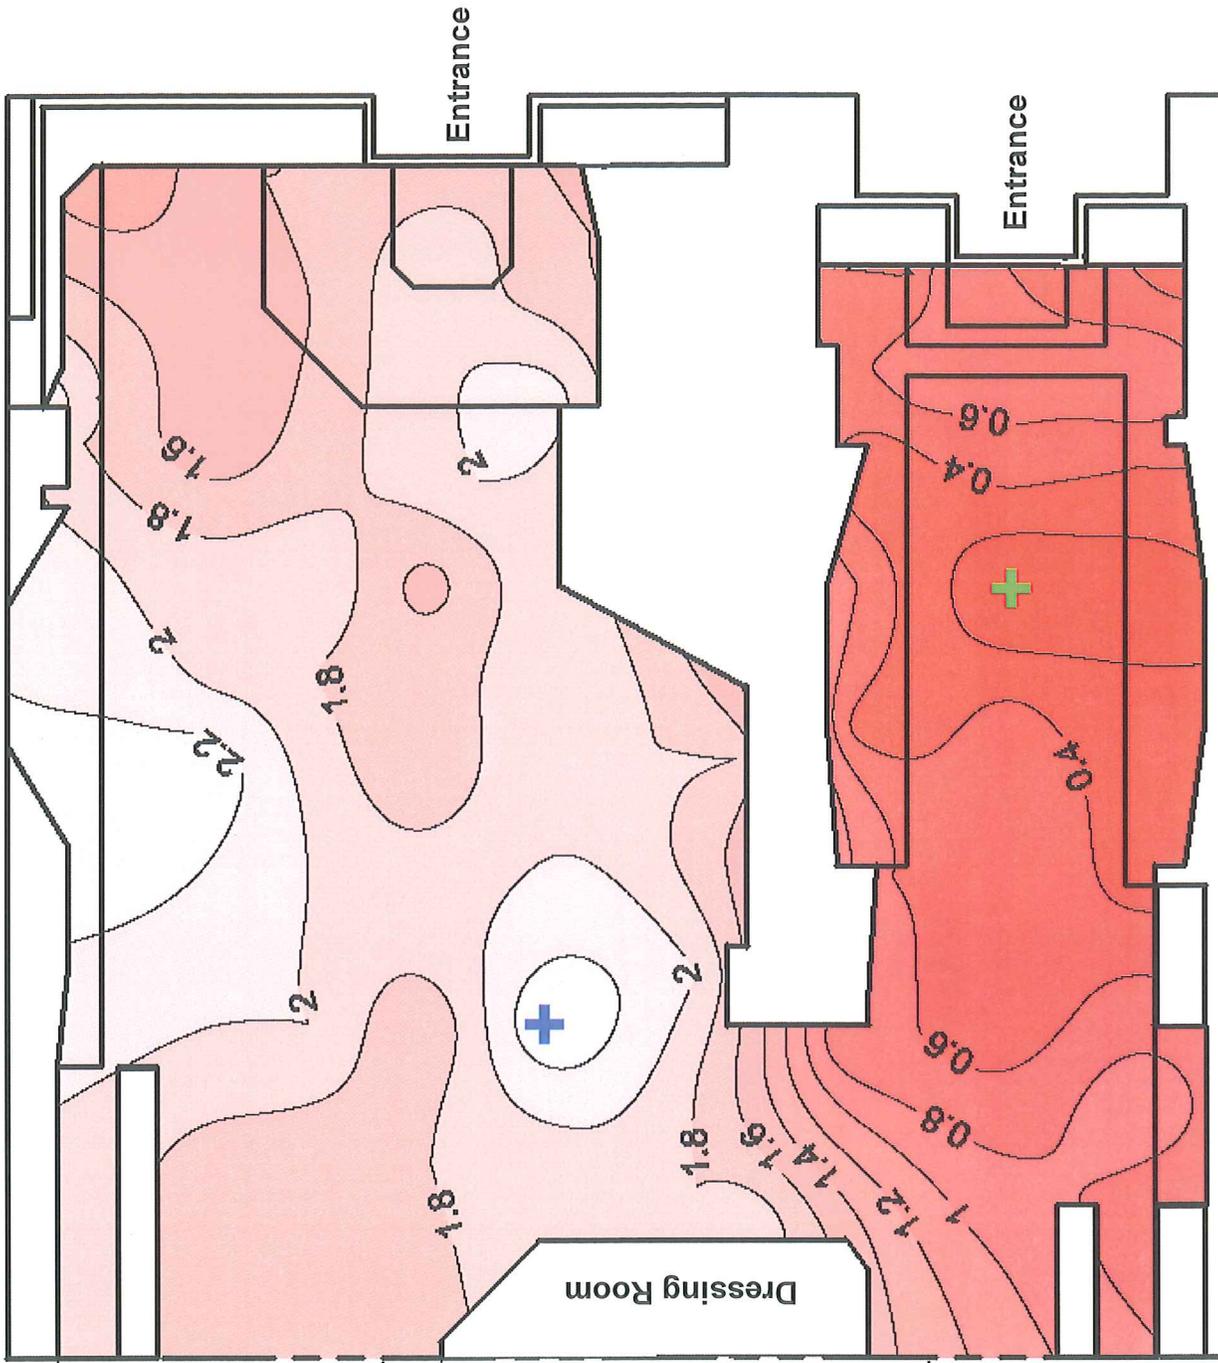
GROUP DELTA CONSULTANTS, INC. ENGINEERS AND GEOLOGISTS 497 S. Lake Ave., Pasadena, CA	FIGURE NUMBER 14
	PROJECT NAME: 497 S. Lake Ave., Pasadena, CA	PROJECT NUMBER GF-2078
CASE NUMBER: BC542643		Date: October, 2015

We conducted a floor level (manometer) survey of the east (front) portion of the structure (Figure 14). A manometer works on the principle that two interconnected columns of water will seek the same level, regardless of the distance between the columns. Using this principle, one water column is placed at a fixed location which serves as the zero point or datum. The other column is provided with a calibrated scale to measure differences in elevation above or below the datum. The calibrated water column is moved throughout the building and differences in elevation relative to the datum are recorded. The data points obtained are then contoured.

The total relief of the measured slab is approximately 2.4 inches (Figure 12). The highest point is located at the middle section of the store, about 10 feet east from dressing room entrance. The lowest point is in the southern portion of store, about 15 feet west of the south side entrance. The most significant elevation differential is located just east of the dressing room, where 1.3 inches of elevation difference is within a horizontal distance of 10 feet.

The northern two-thirds of the slab is relatively level with about 0.8 inches of differential across the north store area. There is an east/west trending high ridge from the entrance toward the dressing room area and another high area adjacent to the northern wall. In the south store area, the slab has the lowest point that is about 0.6 inches lower than the south entrance. These elevation differentials in the slab are consistent with tree root growth: the higher slab near the south entrance; and, the east/west trending high ridge extending west from the north entrance.

The floor level survey data is consistent with tree root growth causing slab uplift. If tree roots under the slab are present and continue to grow, damages related to tree root uplift will worsen.
